Montgomery County Fire and Rescue Service

POST INCIDENT ANALYSIS

Third Alarm House Fire
7105 45th Street
Bethesda, Maryland

Incident Date: September 6, 2013

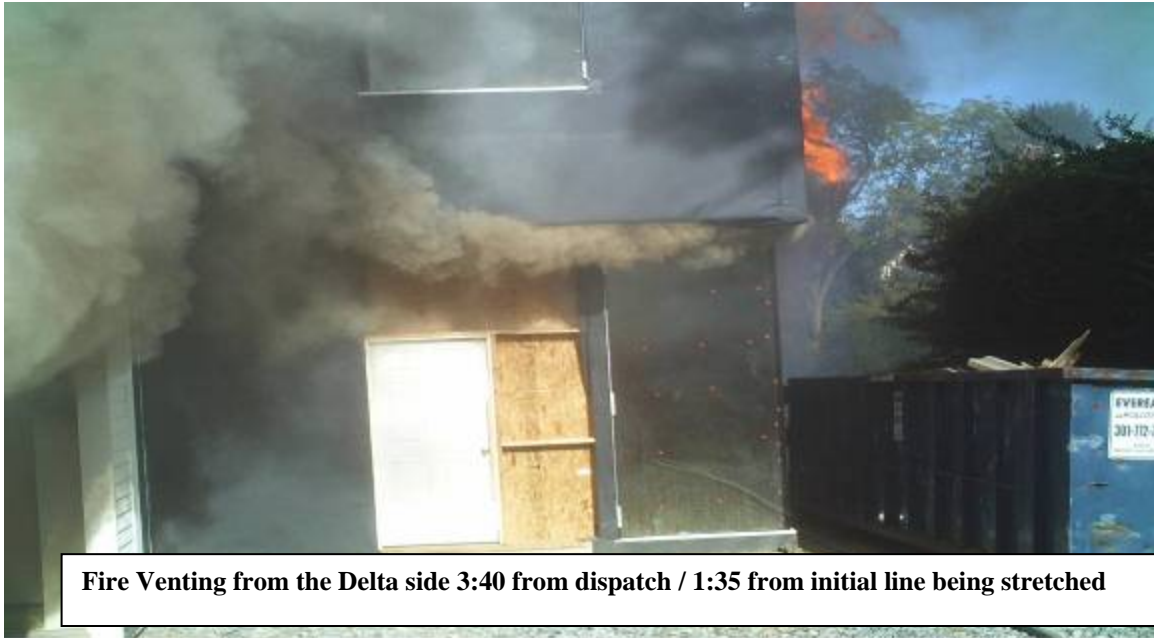
Fire Venting from the Delta side 3:40 from dispatch / 1:35 from initial line being stretched

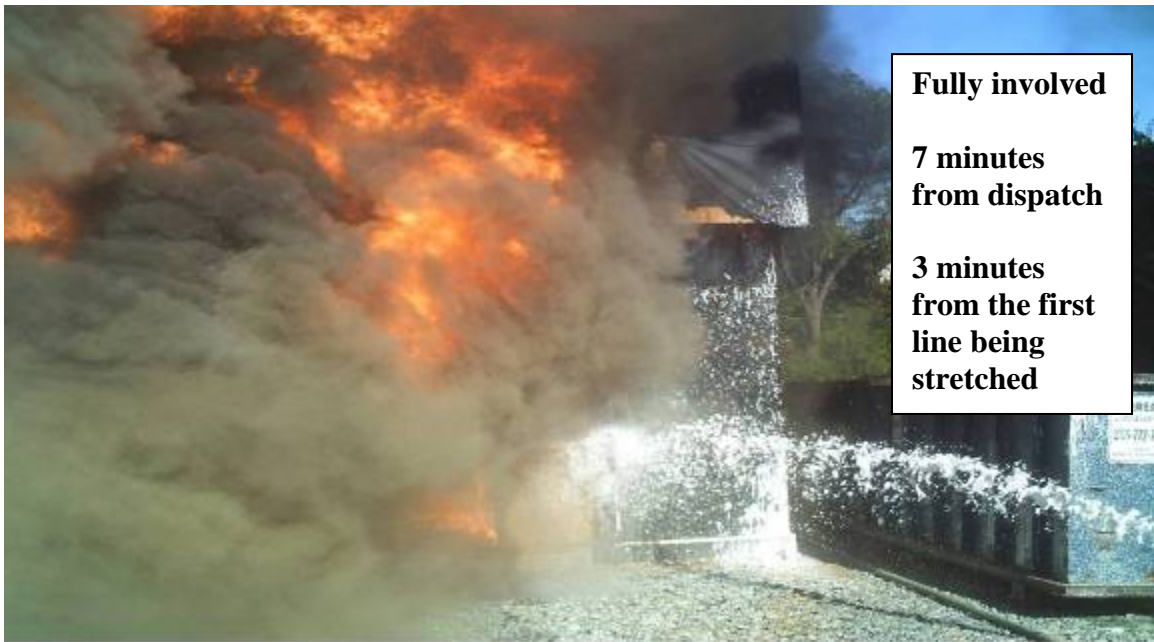
Fully involved

**7 minutes
from dispatch**

**3 minutes
from the first
line being
stretched**

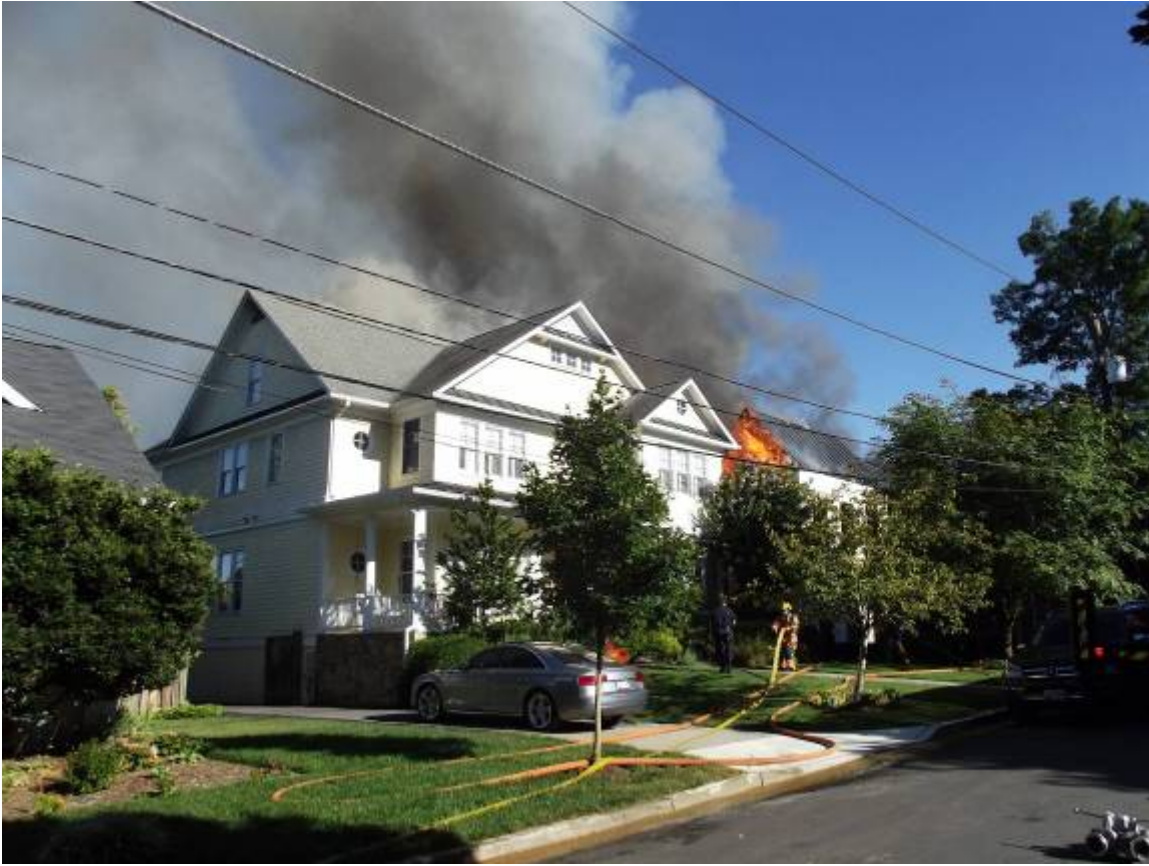
Bravo Exposure

The fire extended to exposure Bravo, a large occupied single family house, via radiant heat and ignition of pine trees between the two structures. Crews worked aggressively in the exposure and were able to hold their positions and extinguish the fire. The fire in this structure was limited to the third floor in the Charlie quadrant which included the attic space behind the knee walls.

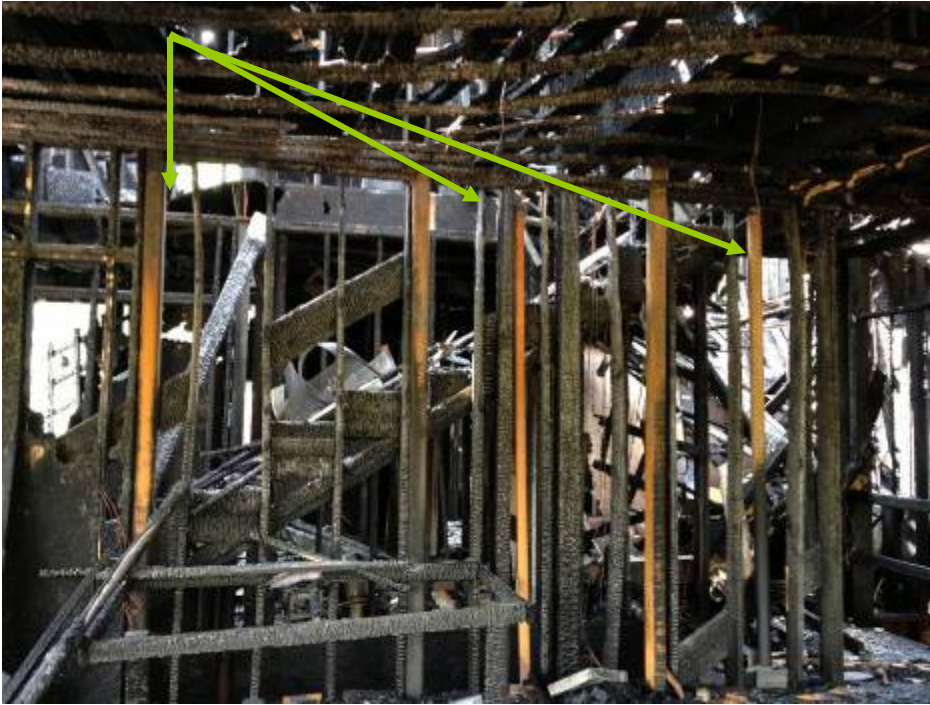
Interior steel columns

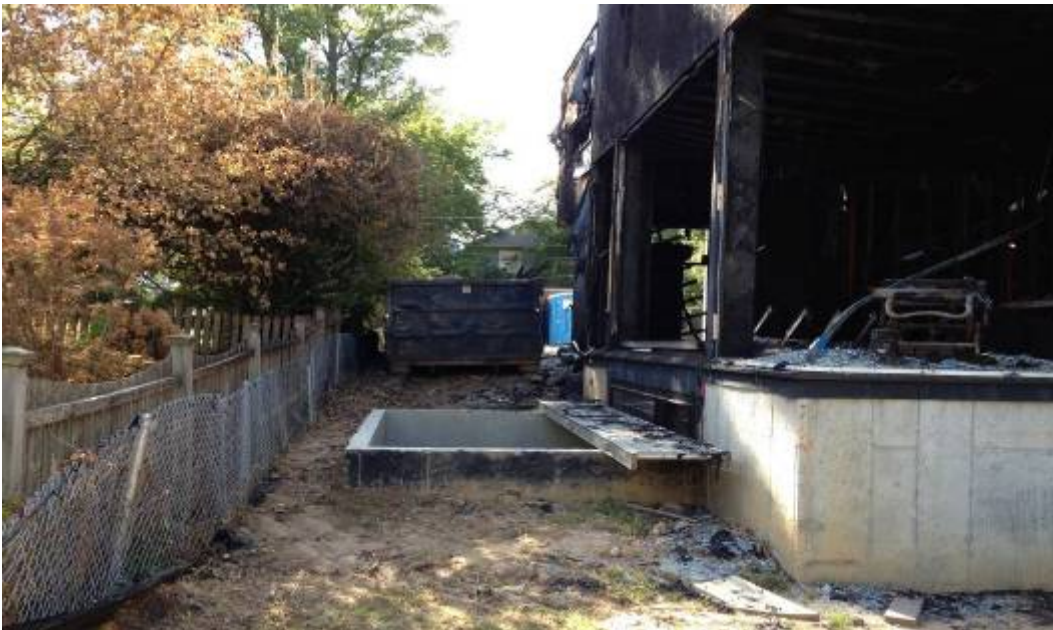
The Delta side viewed from the Charlie side

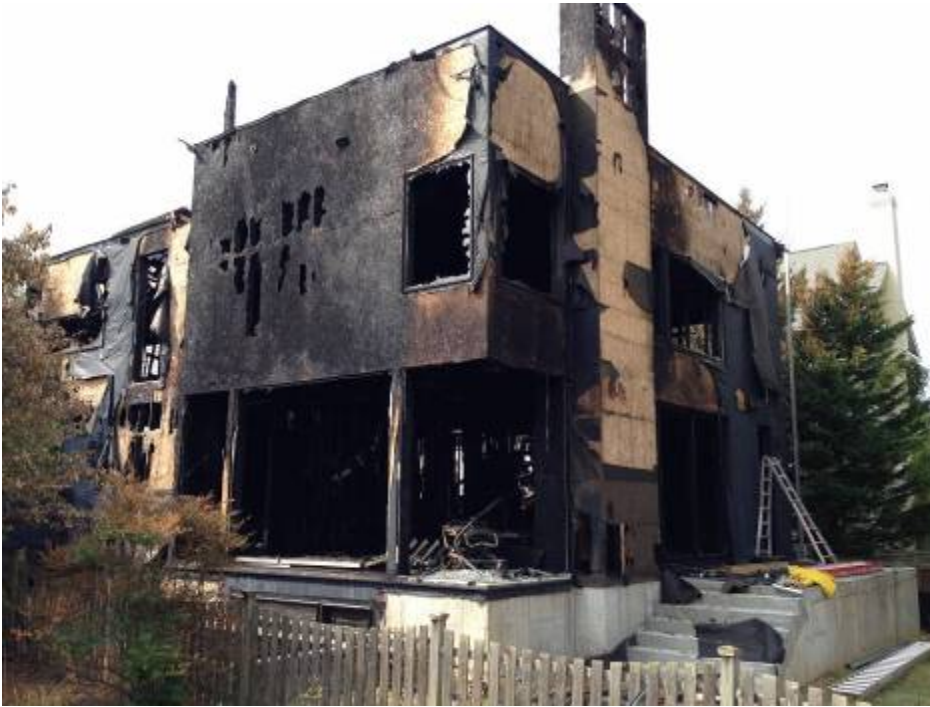
The Charlie/Delta corner

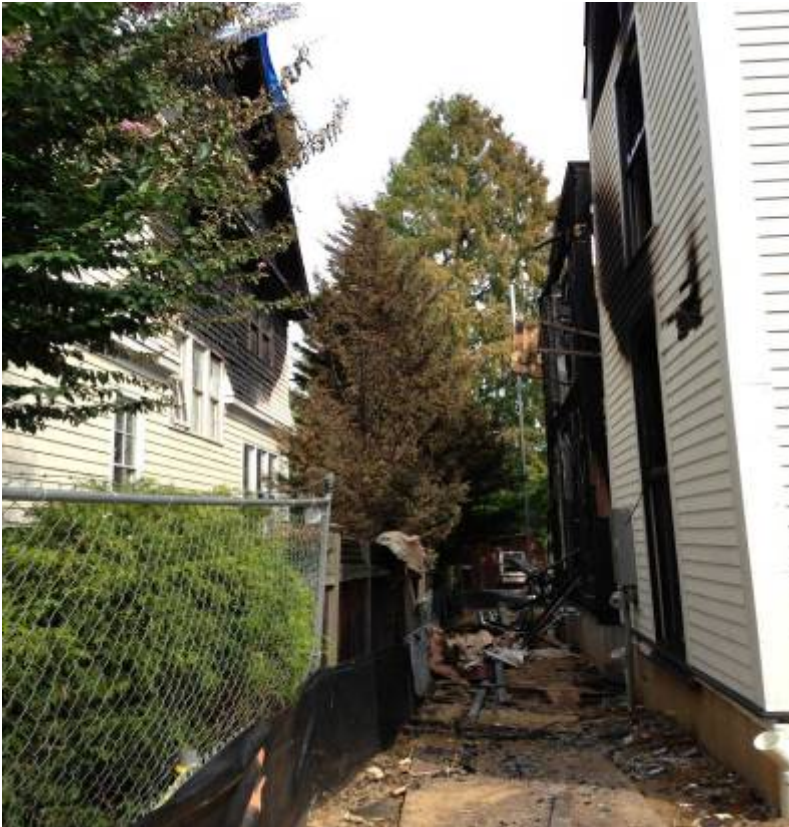
The Bravo side and rear yard viewed from the Alpha side.

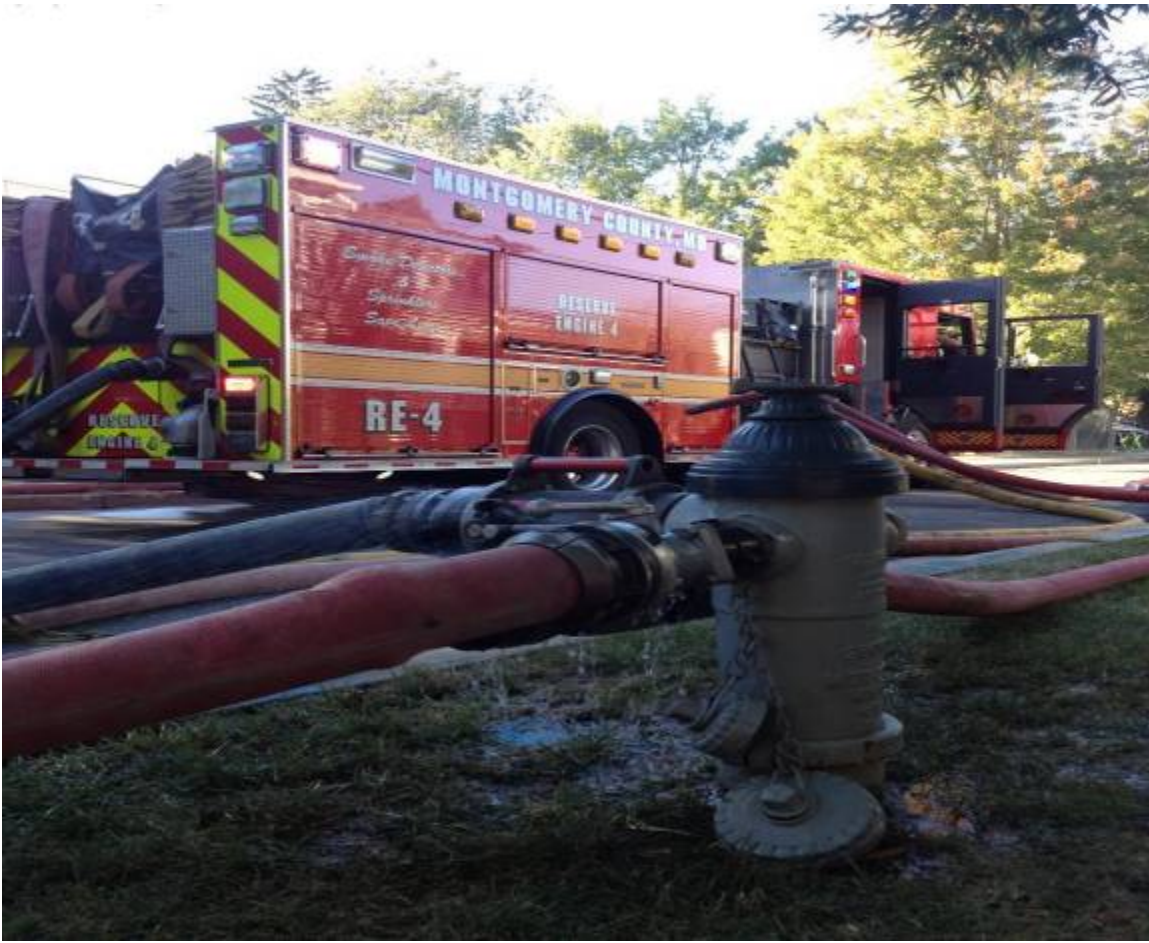
1. The primary hydrant at 4411 45TH Street had a maximum flow of 765 GPM when no other hydrants in the area were opened. The hydrant experienced 10-15 pounds per square inch (PSI) drops in residual pressure if the adjacent hydrants were also opened.
2. The secondary hydrant at 4336 Leland Street had a maximum flow of ~800 GPM
3. The third hydrant used was at 7110 44TH Street and had a flow of 1100 GPM.
4. The fourth hydrant used at 7113 Willow Lane was the primary water supply for interior operations in the Bravo exposure and had a maximum flow of 500 GPM with 0 PSI residual pressure.

Paramedic Engine 707 on the hydrant at 4411 45TH Street
supplying Paramedic Engine 706

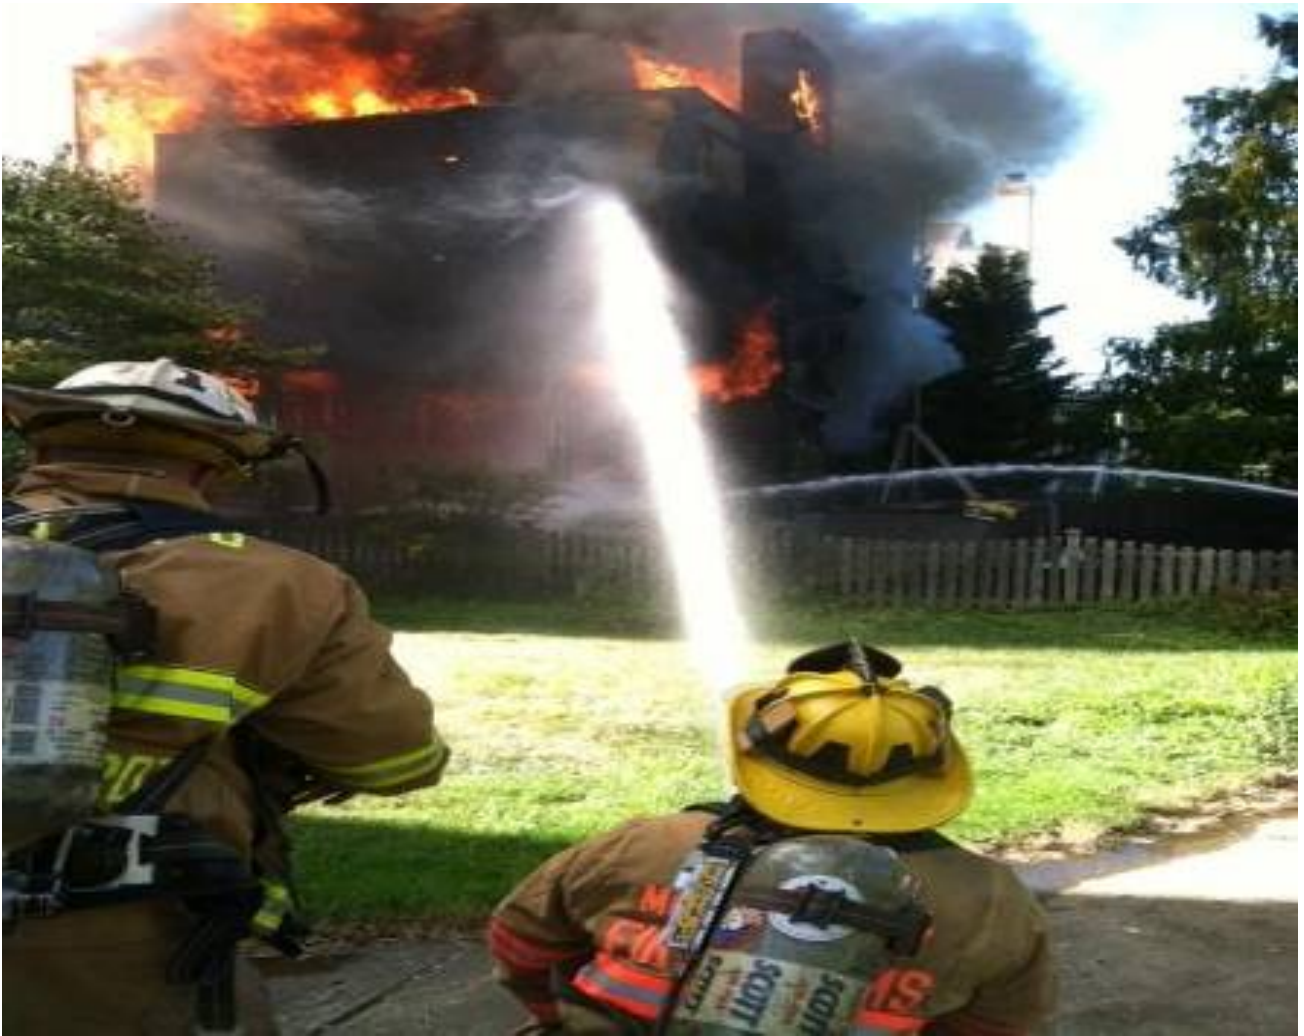
View of Side Delta

Lines must be out of collapse zone but in position to protect exposures and extinguish the fire. This line is too far away.

- In defensive operations personnel must be aware of the collapse zone and operate outside of the collapse zone while still operating close enough so that hose lines are effective.

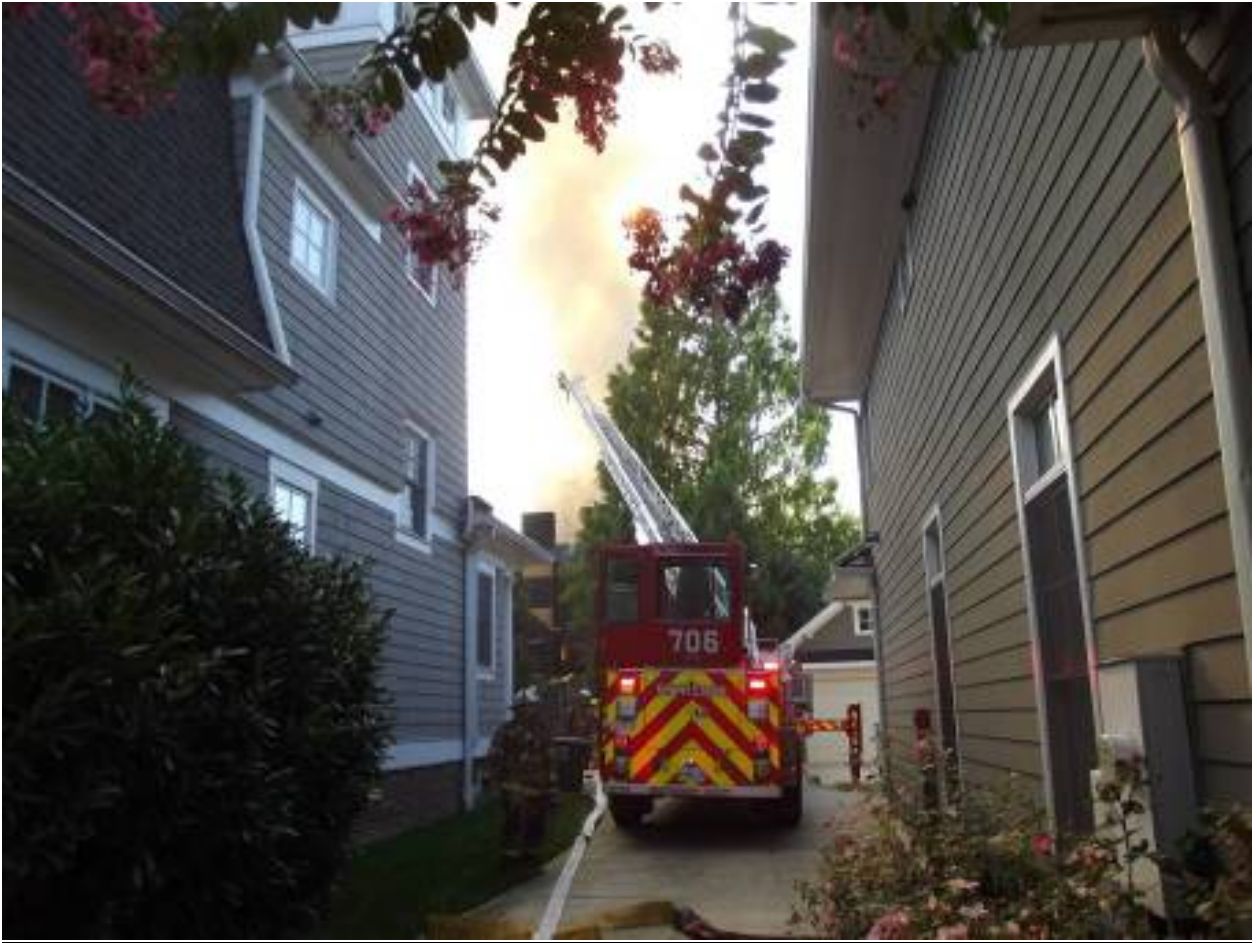
Excellent positioning by Truck 706 – Access to side Charlie from 44th Street

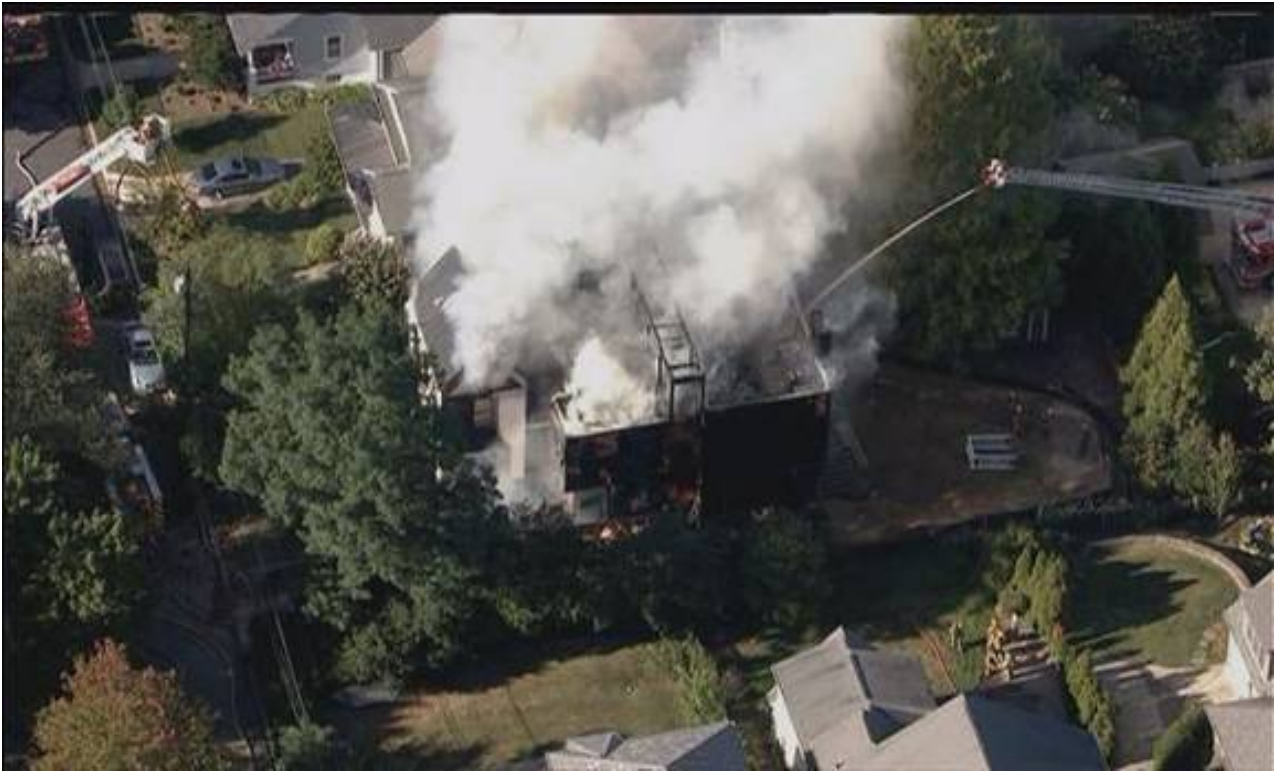
Helicopter Image – Side Alpha on image Left
